Royal Commission on the
Ocean Ranger Marine Disaster

**Report One: The Loss of the Semisubmersible
Drill Rig *Ocean Ranger* and its Crew**

The Royal Commission on the *Ocean Ranger*
Marine Disaster was jointly established and
funded by the Governments of
Canada and Newfoundland

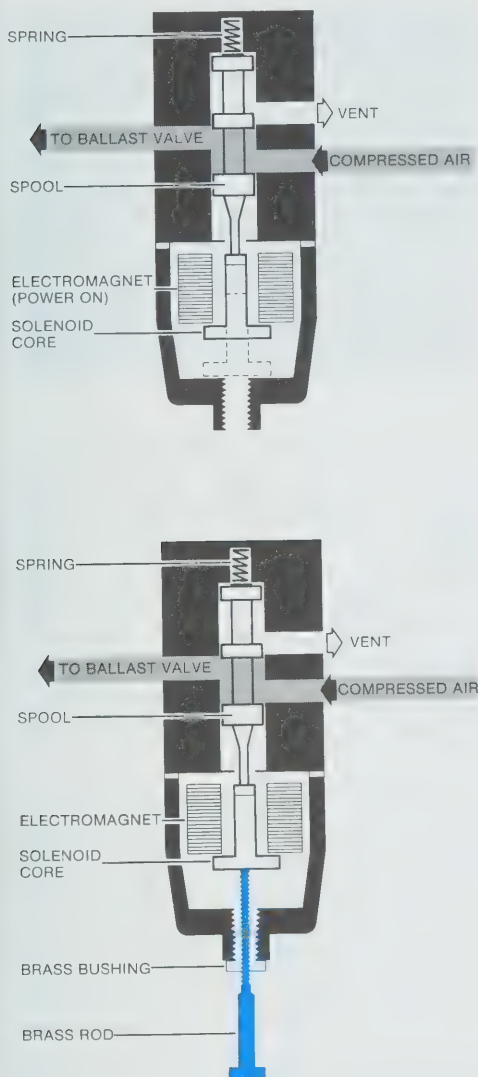
6.3 The solenoid valves could be activated both electrically and manually; a circular pattern of brass residue was found on the core faces of the 18 manually-activated valves recovered from the wreck.

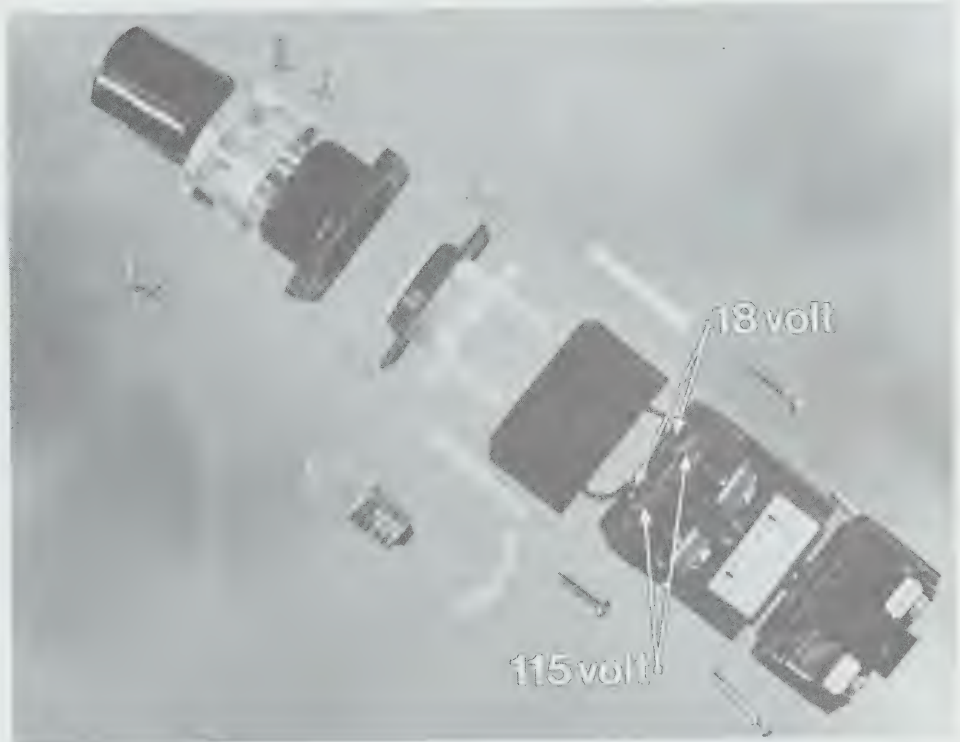
6.6 Valve control switch P-19 was the only mimic panel component which was visibly damaged. The melted area near the base of the housing was caused by a short circuit between the 24-volt and 115-volt terminals.

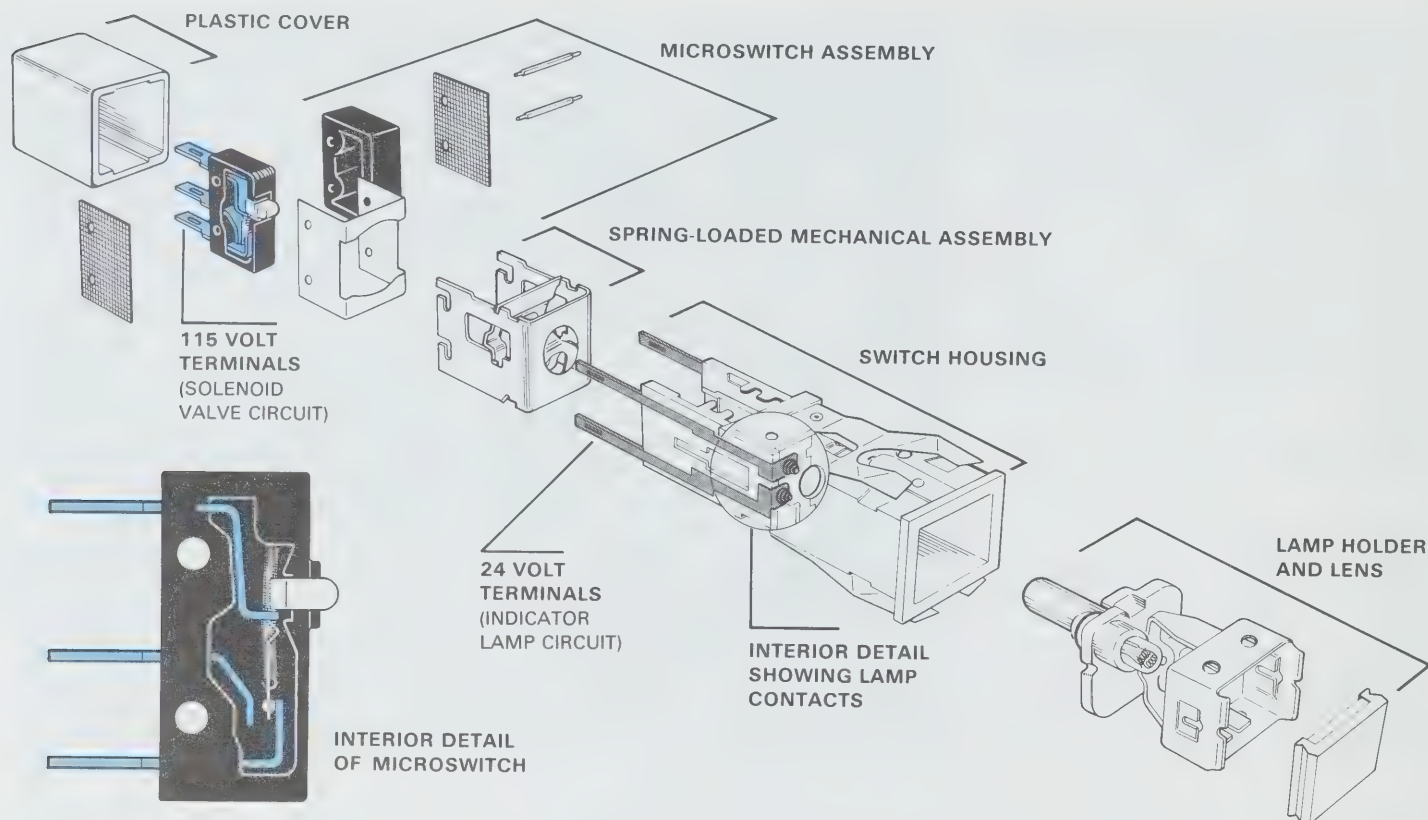
6.7 This illustration shows the components of the valve control switch used in the mimic panel. Short circuiting was found to occur: between the lamp contacts; between the leads connecting the lamp contacts to the base of the switch; between the 24-volt and the 115-volt terminals at the base of the switch; and within the microswitch itself.

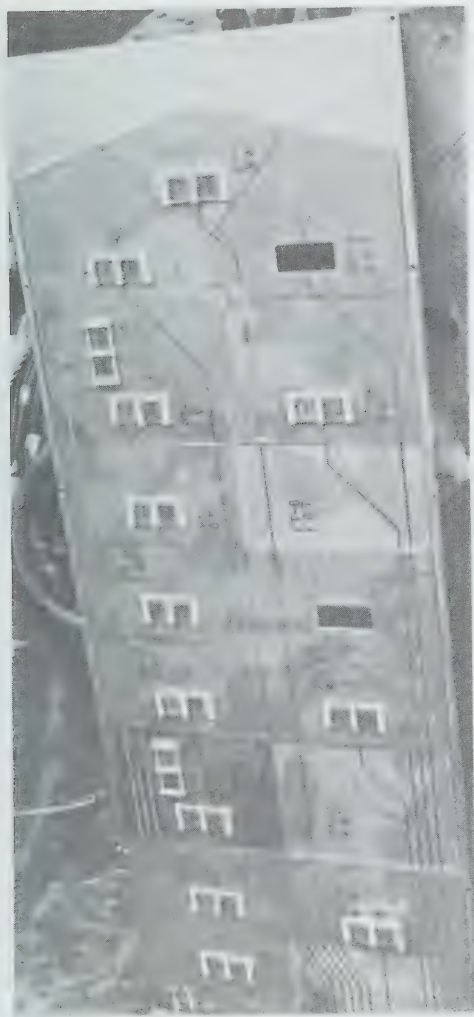
7.4 One of four mimic panel sections recovered from the wreck. Several of the plexiglass insets from the panels were dislodged and lost during salvage.

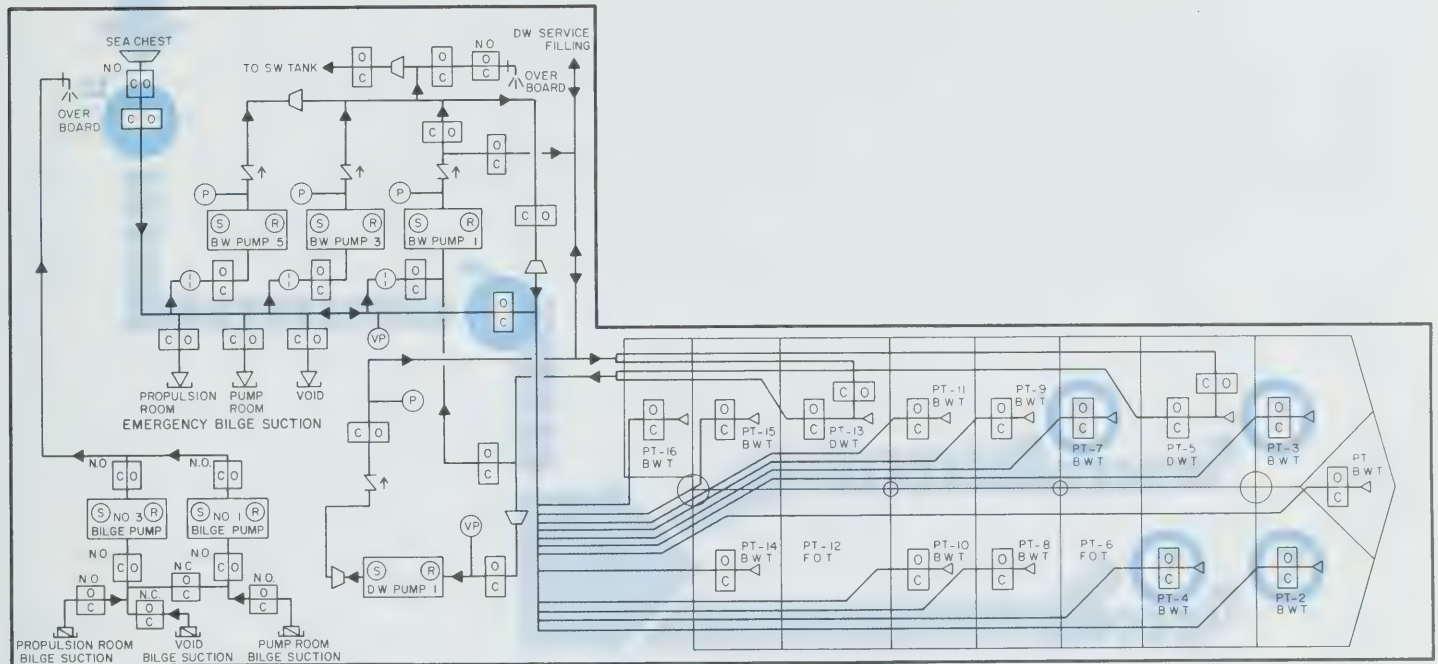
7.5 The accidental opening of ballast valves P-32 and P-20 allowed sea water to enter the common manifold leading to the port pontoon tanks. Open valves leading to one or more forward tanks rapidly lead to a 4-5 degree list by the port bow.

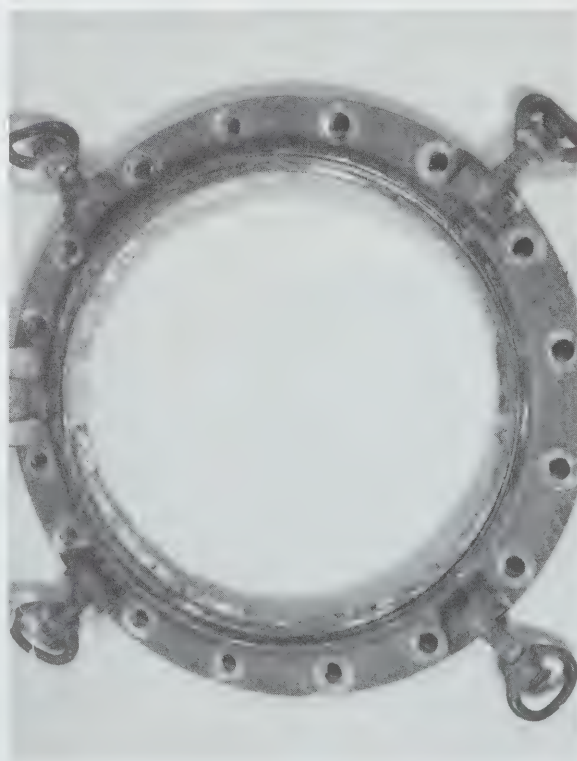
PHOTO 2 Portholes with deadlights open show the glass condition in each case.

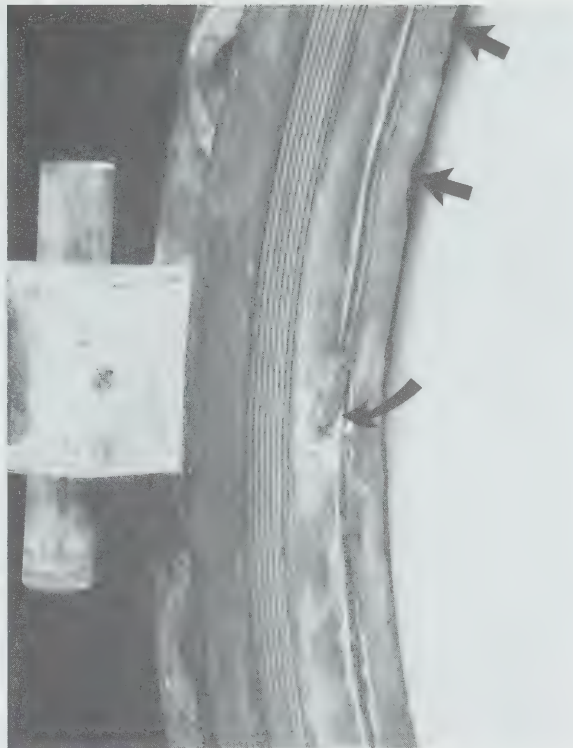
PHOTO 9 Porthole No. 4 showing broken seal (arrows) adjacent to the deadlight hinge. Also note profile of impact marks on outer edge of porthole (arrows) compare with photo 10.

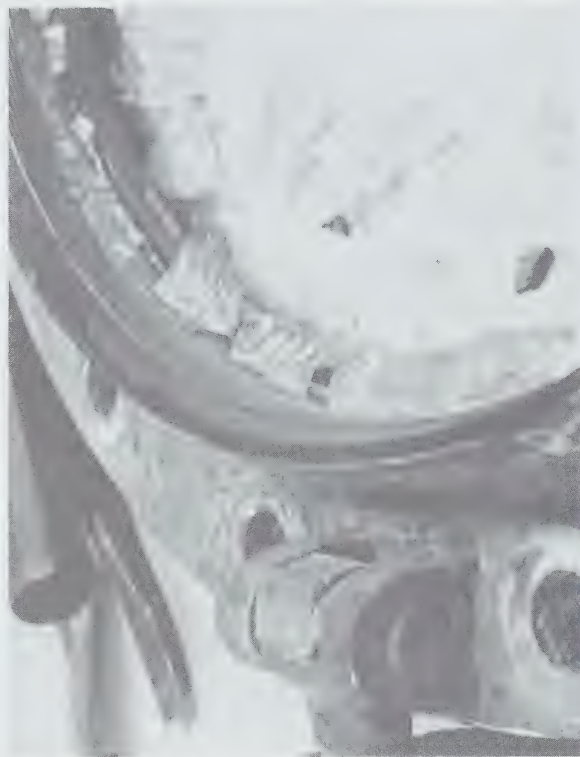
PHOTO 11 Porthole No. 1 glass fragments after removal of the locking ring.

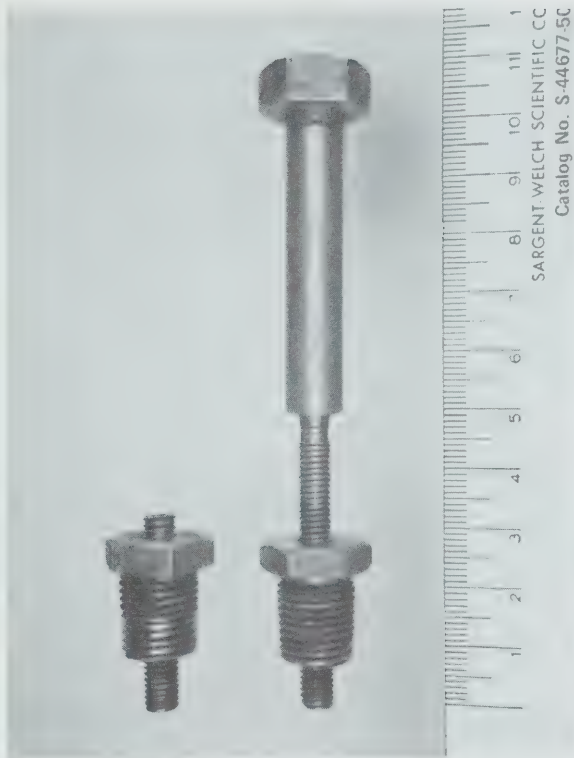
PHOTO 5 A broken and intact actuator rod, inserted into a brass plug.

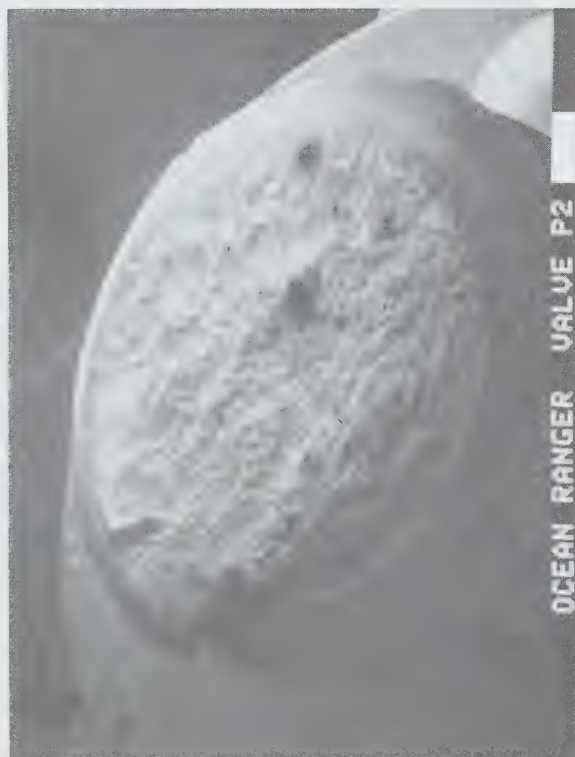
PHOTO 16 SEM photograph showing a typical fracture surface observed in all of the 14 broken actuator rods.

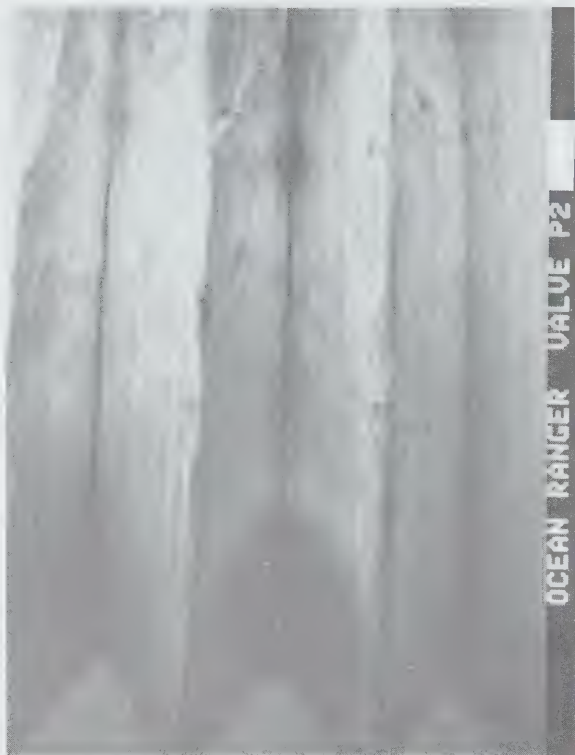
PHOTO 17 SEM photograph showing cracks observed in the thread roots of a failed actuator rod. This was typical for all 14 broken actuator rods examined.

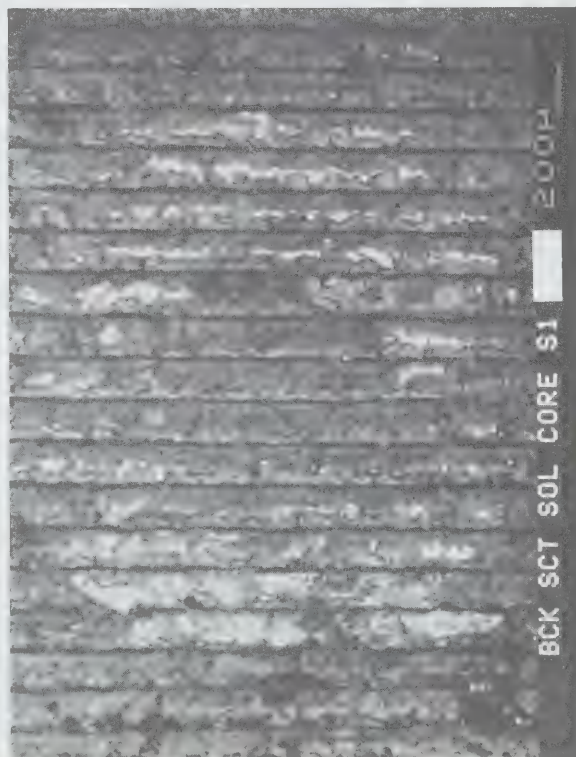
PHOTO 18 Scanning electron micrograph showing a typical brass marking observed on the solenoid core face of valve S1.

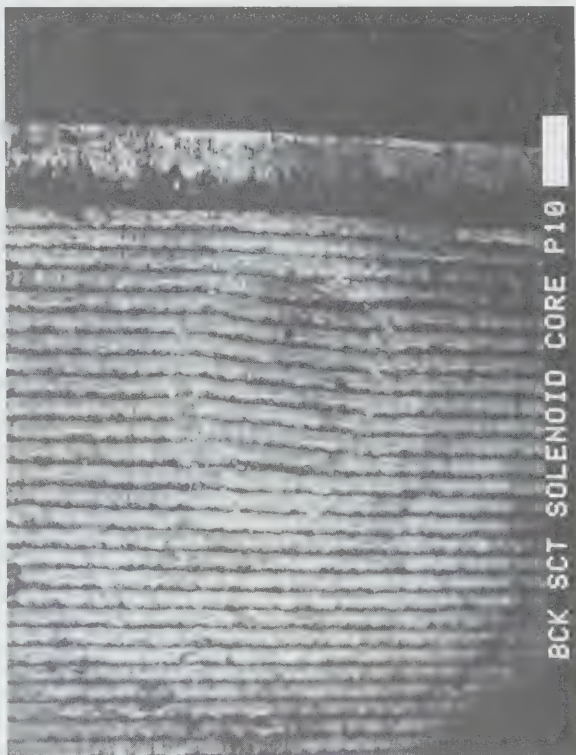
PHOTO 19 Scanning electron micrograph showing a typical imprint as observed on the solenoid core faces of valve P10, S11, S12 and S13.

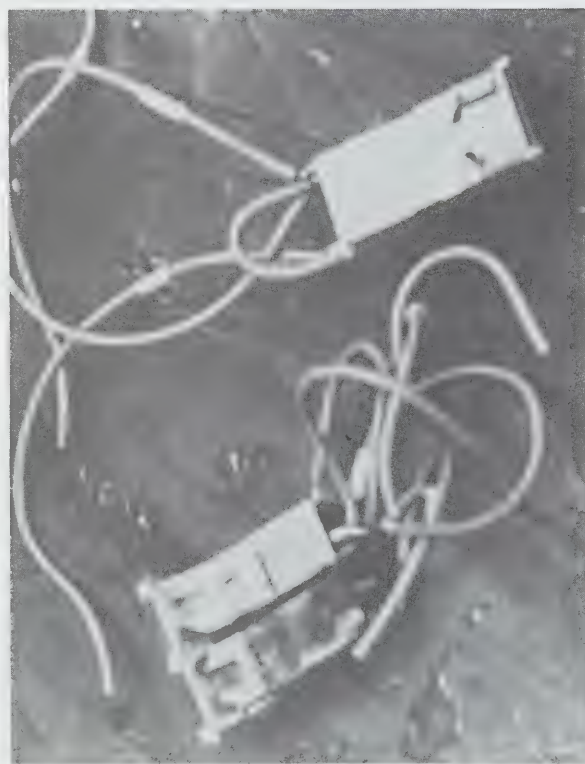
PHOTO 5 Switch P-19 showing sparking damage.

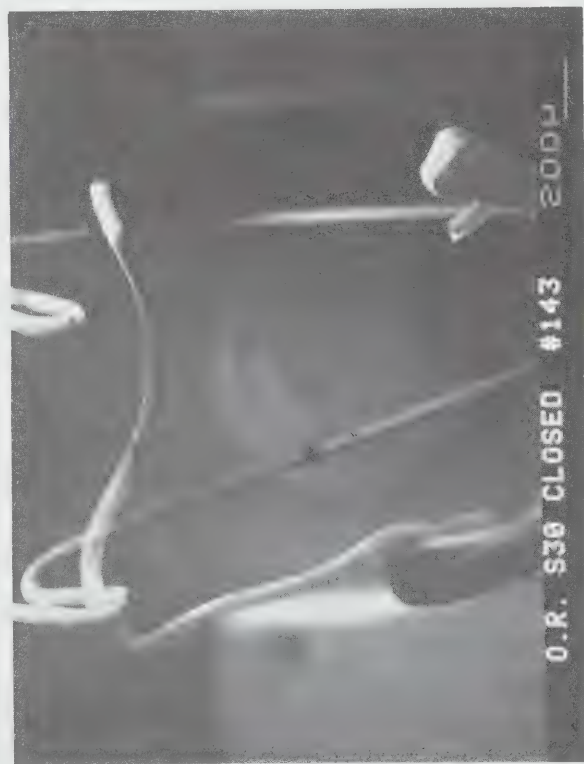
PHOTO 1 Starboard #30 closed. Filament broken near contact post.

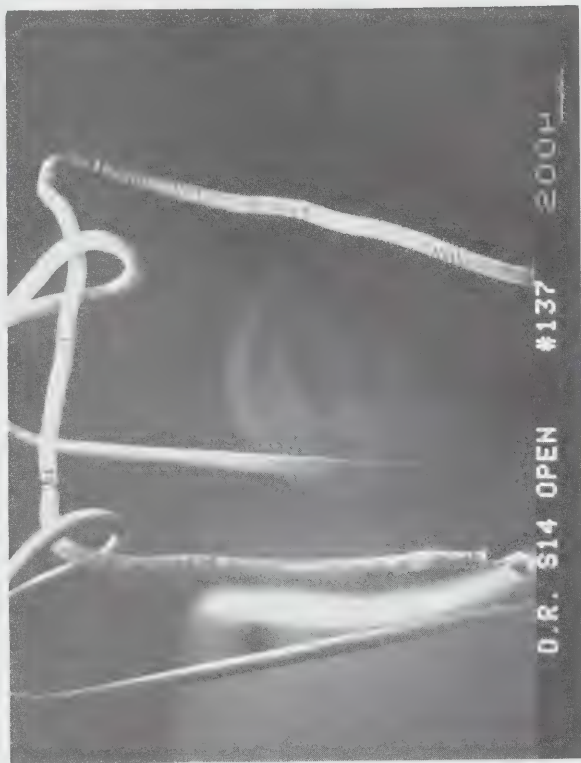
PHOTO 2 Stretched filament damage probably due to high voltage.

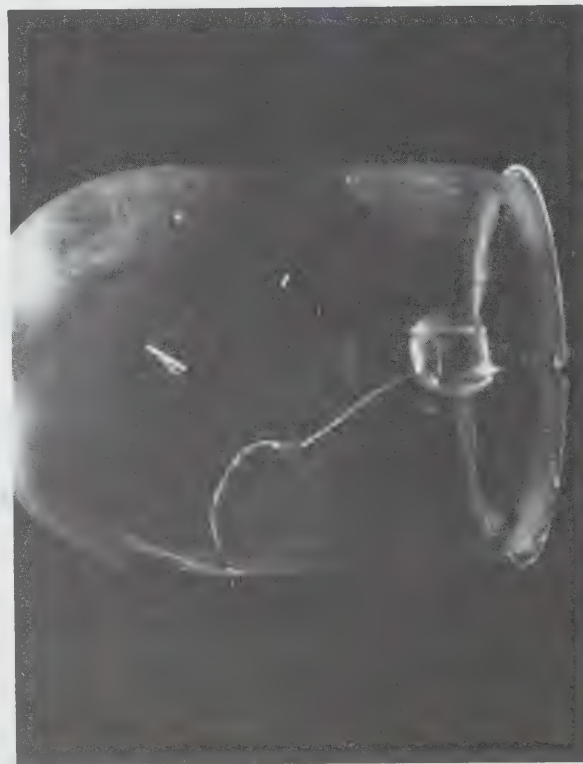
PHOTO 3 Filament fused to glass from #2 bilge water starboard stop pumplight.

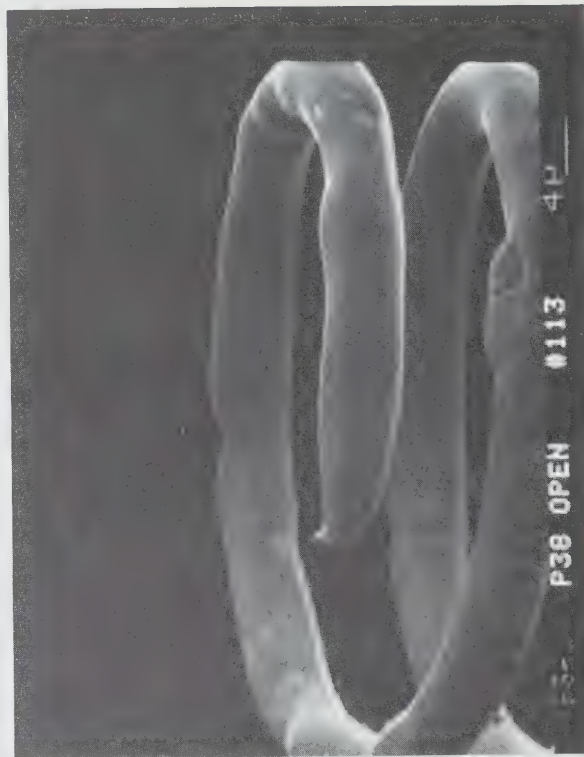
PHOTO 4 Hot fracture of port #38 open bulb.

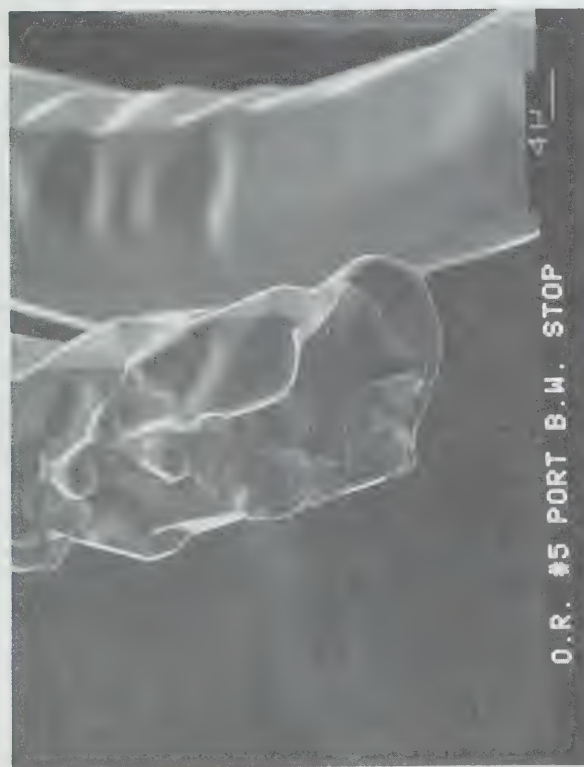
PHOTO 5 Smooth fracture surface of port ballast water stop bulb.

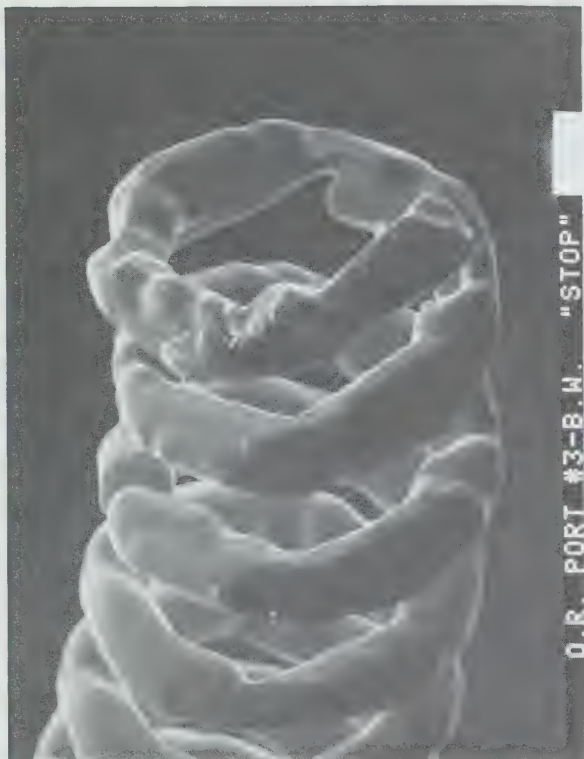
PHOTO 6 Smooth fracture surface of port #3 ballast water stop.

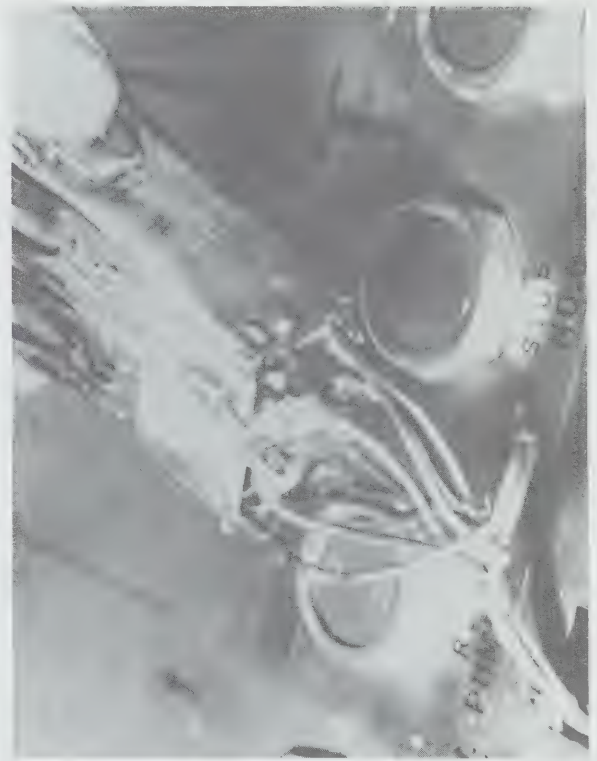
PHOTO 8 Micro command switch showing arcing damage after test.

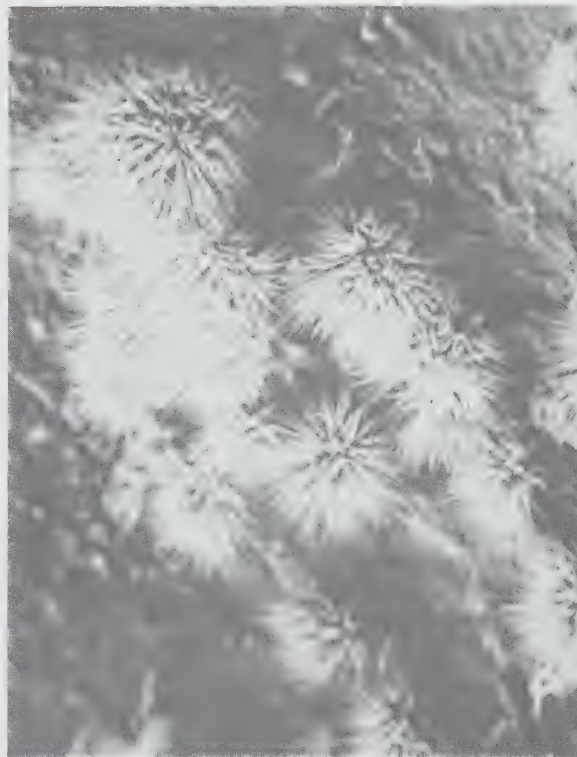
PHOTO 4 Micrograph of the white specks found to be sodium compound crystal clusters.

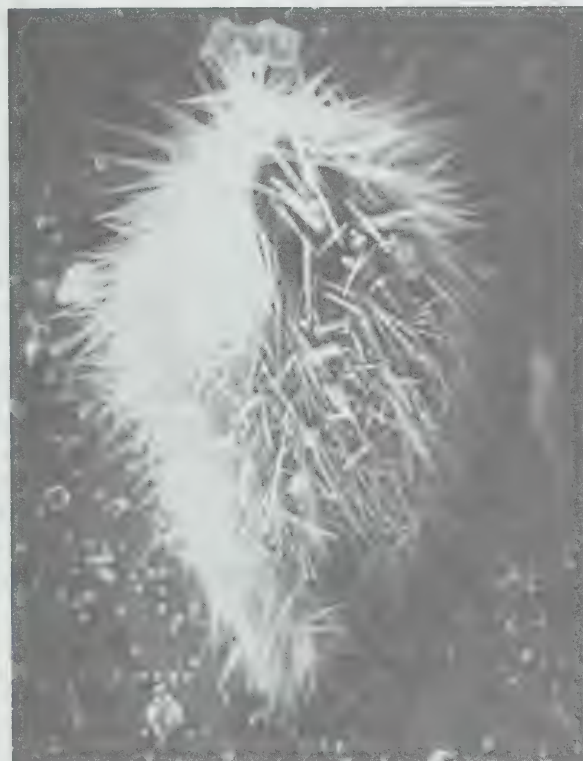
PHOTO 5 Micrograph of a sodium compound crystal cluster surrounded by small sodium chloride crystals.
